# CONSOLIDATION OF CATHEDRAL OF PORTO

*Paulo B. Lourenço, ISISE, University do Minho, Department of Civil Engineering  
pbl@civil.uminho.pt*

The present paper presents the works recently carried out at the Cathedral of Porto as a case study of a difficult intervention that challenges current recommendations for the architectural heritage. The aspects regarding structural consolidation are addressed, including strengthening and monitoring of the towers and diagnostics of a chapel.

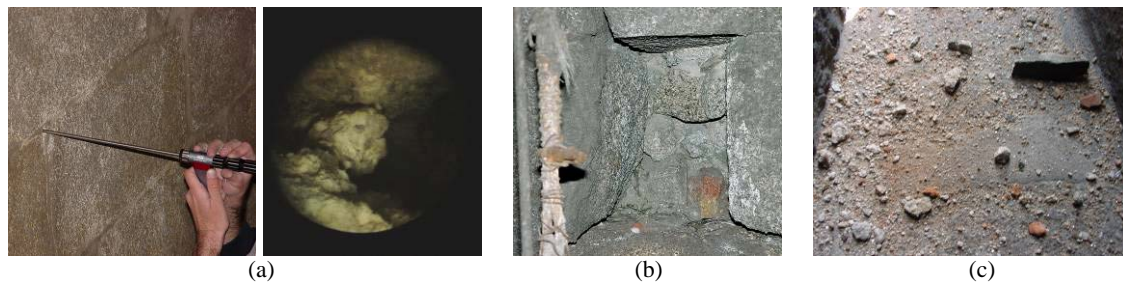
The constitution of the masonry walls from the towers was characterized using visual inspection, both by removing smaller stones of the outer leaves and by using a boroscopic camera inserted in cracks or in holes drilled in joints, see Figure 3a. From the inspection, it was possible to conclude that the three-leaf walls have external leaves of granite ashlars with a thickness ranging from 0.30 to 0.70 m, while the middle leave is made from loose smaller stones and / or silty soil, see Figure 3b and Figure 4. The combination of heavy rain in Porto, strong winds in the top of the hill where the Cathedral is located, and the open joints in the external masonry face, results in a wet infill even in the summer and the continuous washing out of the infill, see Figure 3c.

Figure 3. Visual inspection to define the constitution of masonry walls: (a) boroscopic camera, (b) opening up the structure (c) loss of material through central cracks in the openings.

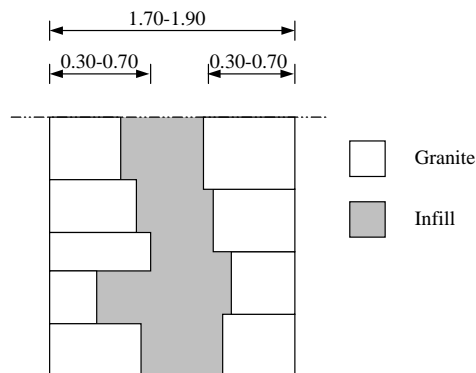
Figure 4. Typical cross section of the masonry walls.

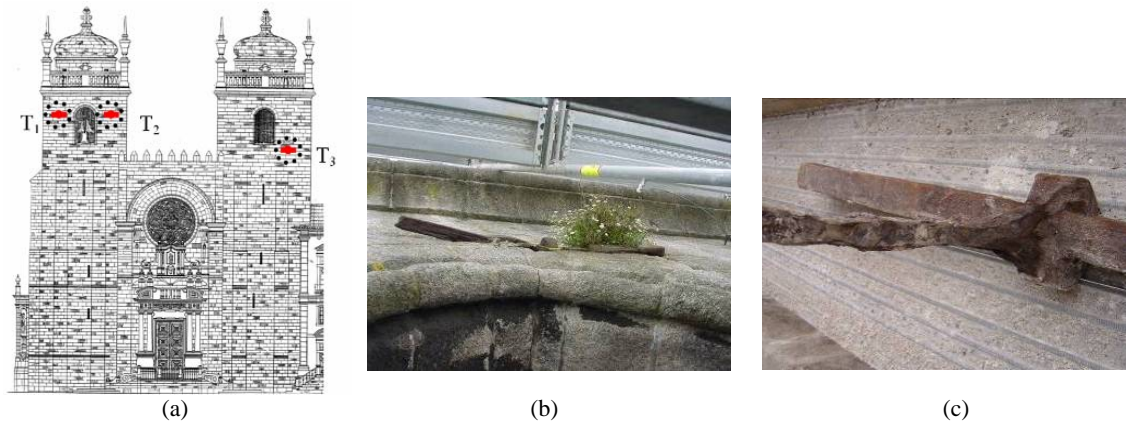
The towers exhibit distributed cracking and significant out-of-plane movements. The existing damage resulted in the past addition of three iron ties (date unknown), see Figure 5a. Tie T1 presents a severely deformed anchorage, see Figure 5b, and tie T3 is corroded and broken, see Figure 5c. It is stressed that the separation between the East and West façades of the South tower continued after tie T3 was broken. It is also noted that the masonry walls in the vicinity of the anchorages are also deformed, as expected due to the application of a large point load.

Figure 5. Ancient tower ties: (a) Deformed anchorage of tie T1 and (b) details of broken tie T3.

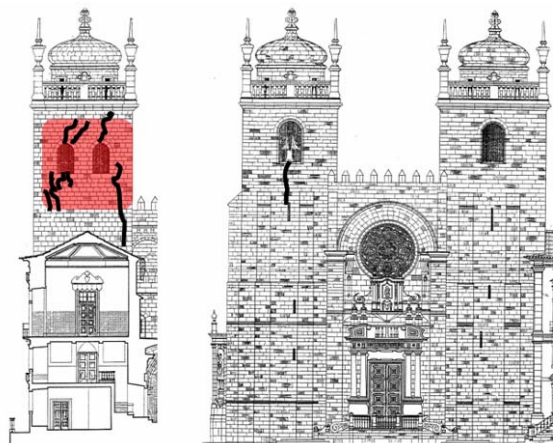
The South tower is more damaged than the North tower. Figure 6 exhibits the location of severe cracks and out-of-plumb walls in the South tower. Also the East façade of the South tower presents out-of-plane movements to the exterior. It is noted that the internal walls of this tower are straight, indicating crumbling or desegregation of the walls, with major cracks and voids in the interior, see Figure 7a. The separation between the internal and external leaves of the walls is further confirmed by the longitudinal cracking observed in most of the openings. Figure 7b illustrates such cracking, with a maximum width of some centimetres. Finally, it is noted that the North tower presents severe distributed vertical cracking at the base, see Figure 7c.

Figure 6. Location of most severe cracks and out-of-plumb walls, in the South view and main façade.

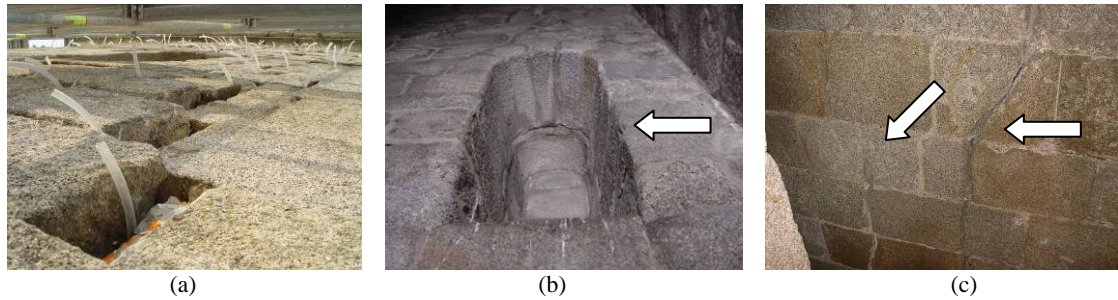
This cracking is only visible in the internal (medieval) face, while the external face seems undamaged. Moreover, the very large thickness of the walls is not replicated in the South tower. For these reasons, it is believed that the damage is not recent and the helicoidal staircase with vertical cracking belongs to the structure of an older tower.

Figure 7. Details of the cracks in the towers: (a) cracks up to 0.20 m width in the South façade / South tower; (b) typical active cracks parallel to the walls at the openings; (c) vertical cracks at the base of the North tower.

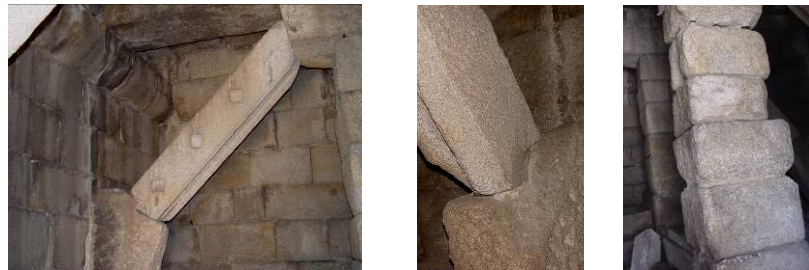
Additionally, also the following damage is noted: (a) Steel structure in the cupolas of the towers with advanced corrosion; (b) Balustrades and pinnacles under deficient stability conditions and with significant movements due to corrosion of dowels and ties; (c) Misconception of the structure supporting the bells and clock in the North tower, see Figure 8.

Figure 8. Deficient structural system to support the bell stone level floor.

In the North tower, the ring also aims at providing a support for the stone pavement for the bells. The reason being that the stone columns are very deteriorated and possess presently no structural function and the stone struts have very deficient

conception, see Figure 9c. Here it is noted that it was decided not to recuperate the structural function of the columns (e.g. using injection) because the lower level seems to indicate insufficient strength of the inner core, see Figure 9c and Figure 8. The steel ring is made of U profiles ( $240 \times 120$  mm and  $200 \times 100$  mm height).

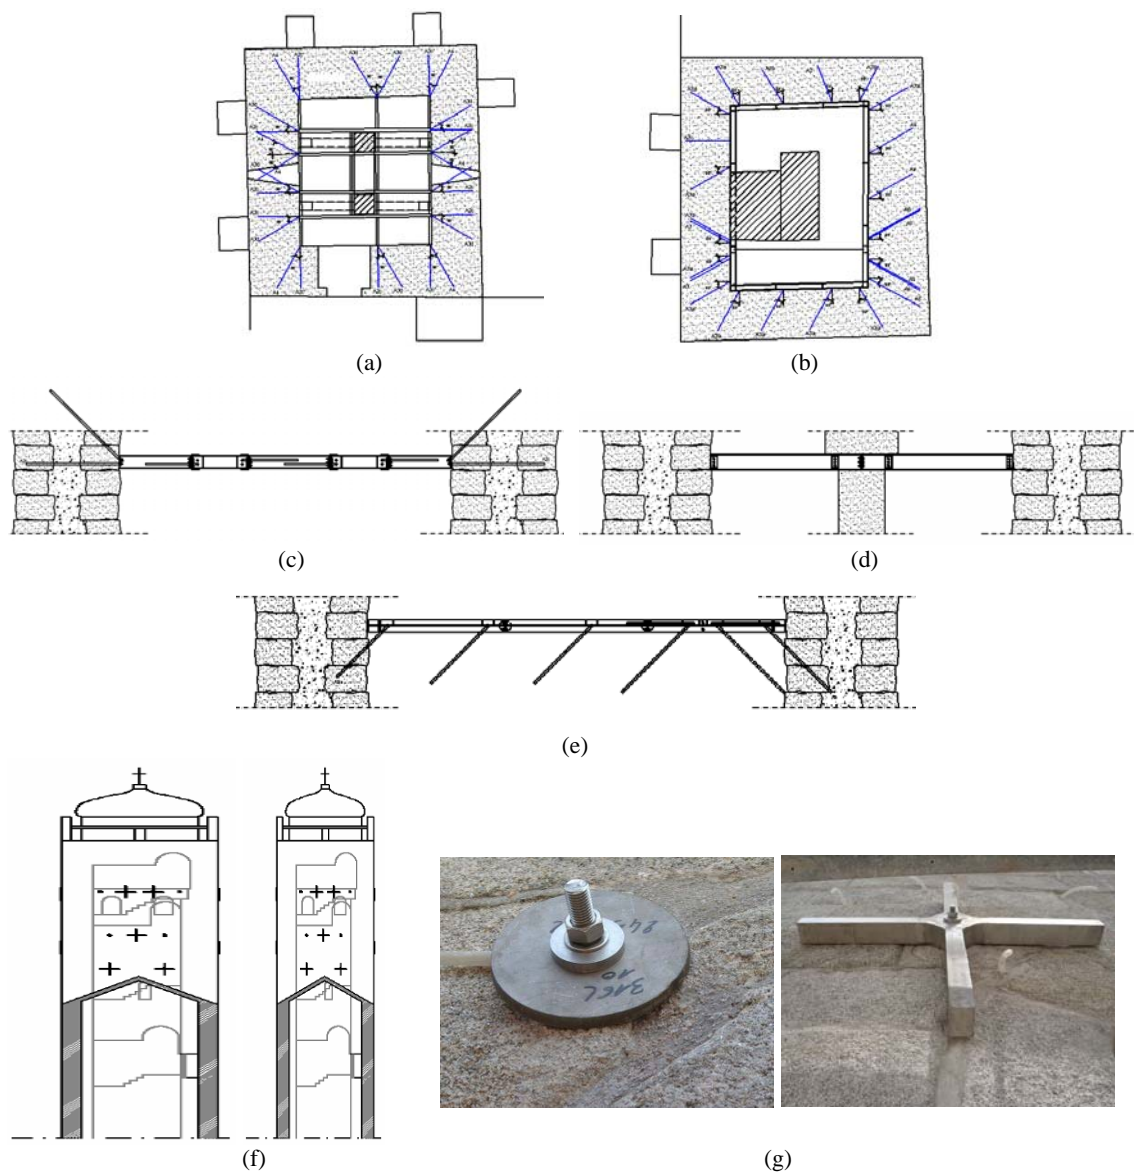
The walls of the towers seem not to possess adequate connection between the external leaves and severe water infiltration in the walls contributed to the existing damage and to the loss of material in the rubble infill. Here it is again stressed that the Cathedral is located at the top of a hill, the masonry joints have lost all mortar and it was found that the rubble infill was wet by the end of the summer. Besides other damage, the most relevant feature is that the North tower is divided in two similar U-shaped parts, from mid-height to the top, with full cracks along the West-East direction (in the other direction, the existing ties kept the tower together), and the South tower is bulging outwards both to South and to East (the existing West-East tie is broken).

The solution adopted for strengthening consists mostly of a steel ring in both towers, aiming at confining the structure along the two orthogonal directions, in the sole location possible, see Figure 9a,b. The rings are made with welded stainless steel plates (class AISI 316L), connected to the towers using long, inclined stainless steel anchorages inside of a cloth duct to prevent generalized injection, see Figure 9c-e. The length of the steel profiles is defined so that the elements can be transported to the location through the existing doors and can be easily assembled in situ, without any further welding.

In the South tower, a set of two ties was provided to the ring, because it was possible for aesthetic reasons and they are a witness of the ancient broken tie. The ring must cross the staircase at a selected location because the complex internal structure of the tower does not allow otherwise. Due to the lack of internal stiffening elements, a much more stiff steel frame is needed and the steel ring is made of I profiles ( $180 \times 180$  mm). Due to the bulging outwards of the East and South façades, and the severe cracks in the corners, several short ties have been added to the structure to stitch the East and South façades, and two long ties through the core of the South façade have been added to connect the West and East façades, see Figure 9f. Figure 9g presents details of the two types of anchorage plates adopted (circular plates and specially designed crosses).

Figure 9. Aspect of the strengthening of the towers using stainless steel rings and long inclined anchorages: (a) plan of the ring for the North tower; (b) plan of the ring for the South tower; (c) North-South section for North tower; (d) West-East section for North tower; (e) typical section for South tower; (f) additional ties placed in the West and South façades of the South tower; (g) details of the anchorage plates.

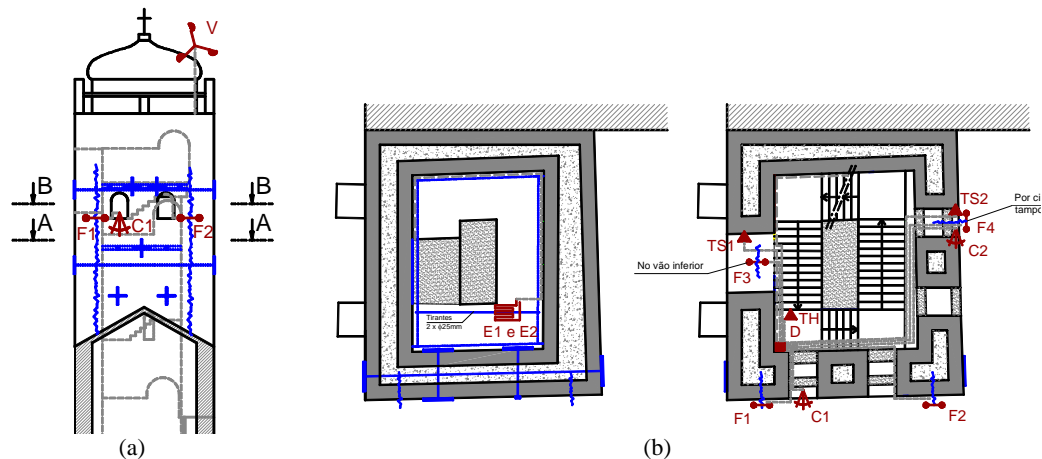
Given the cultural importance of the building and the significant damage in the South tower, a monitoring system was planned and installed. The system includes four waterproof crackmeters in the largest cracks, two strain gages for the new ties, two biaxial clinometers to measure the tilting of the tower, as well as temperature, humidity and wind sensors, see Figure 10 and Figure 11. The system includes a datalogger and a GSM interface for remote monitoring, see Figure 12. An example of the measured values, for the crackmeters and temperature sensors, indicate minor variations and the typical seasonal effects, thus confirming the adequacy of the intervention measures.

Figure 10. Monitoring system in the South tower: (a) South view; (b) plan. Here, F1 to F4 indicate crackmeters, E1 and E2 are vibrating wire extensometers, TS1 and TS2 are temperature sensors, TH is a combined temperature and relative humidity sensor, C1 and C2 are tiltmeters and V is anemometer capable of measuring wind direction and velocity.

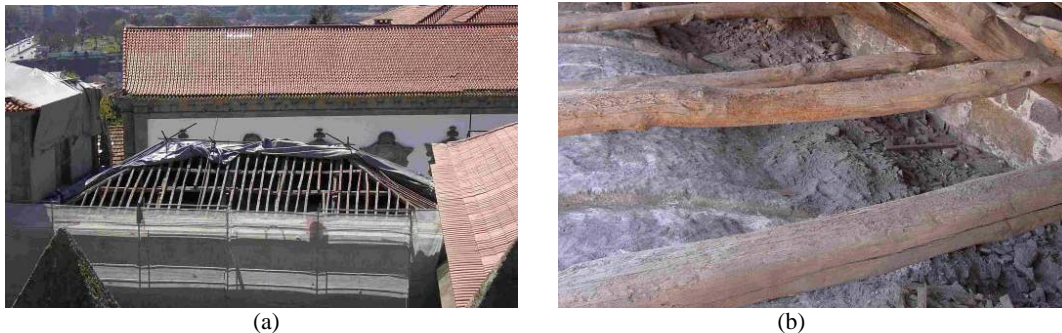
The Saint Vincent Chapel is located next to the South wing of the Cathedral cloister. During the restoration works of the roof, it was found that the extrados of the chapel vault was filled with rubble resulting from old demolitions see Figure 14. Also, and as usual in several historical constructions, the timber roof was partly supported by the vault, using later added struts. The issue addressed here is the stability of the vault and the convenience of the removal of the infill.

Figure 14. Roof of Saint Vincent Chapel: (a) aspect of restoration works; (b) aspect of vault infill with rubble.

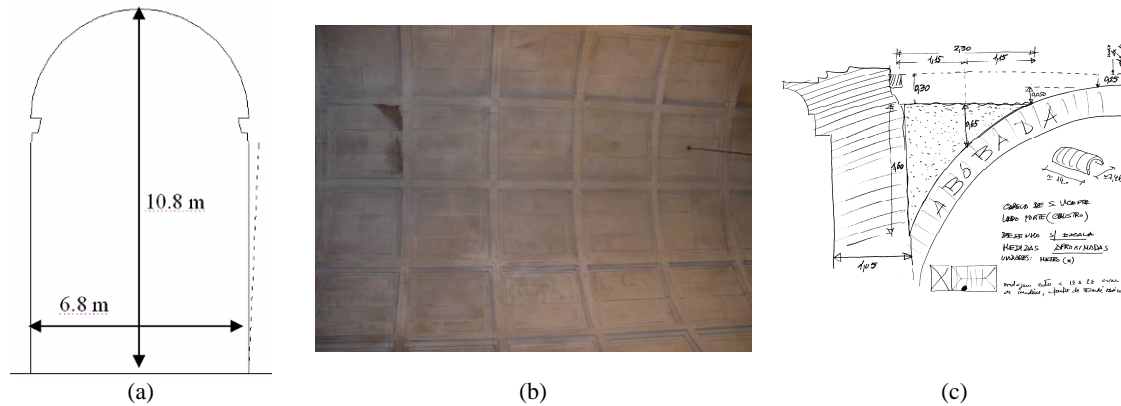
The structure consists of a barrel vault with an approximate thickness of 0.25 m and a span of 6.8 m. On the North side, the cloister acts as a buttress but on the South side no buttresses are present. Even if the South wall (1.70 m) is thicker than the North wall (1.30 m), out-of-plumb movements outwards are clearly visible in the former, up to 1.5% (or 0.10 m at the springer of the vault), see Figure 15a. Nevertheless, as the vault presents only minor cracking, see Figure 15b, it was believed that the vault has been built after the wall deformation. As it will be confirmed next, the vault replaces a previous timber roof at the same level. From inspection pits, see Figure 15c, the geometry of the vault could be determined.

Figure 15. Saint Vincent Chapel: (a) cross-section with 1.5% out-of-plumbness on external (right) wall; (b) aspect of vault intrados; (c) aspect of survey from inspection pit.

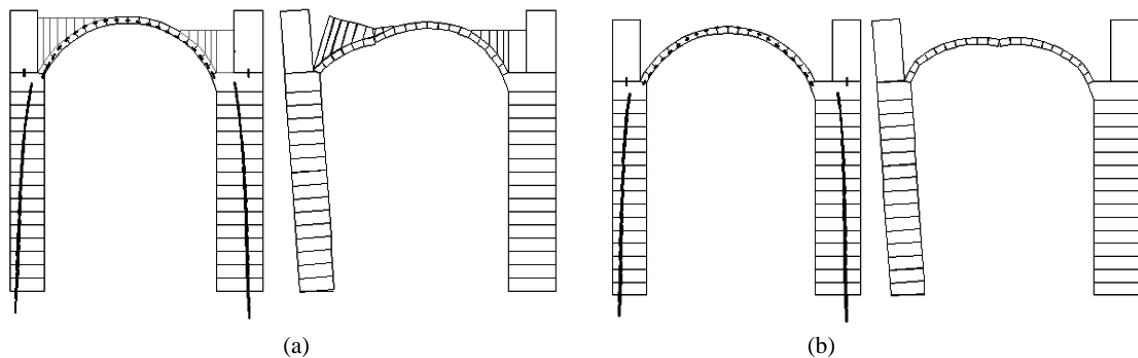
As the objective of the analysis is to evaluate the influence of the infill, a sophisticated representation of the structure is not particularly relevant. Therefore, the influence of the cloister, openings of the walls and ribs of the vault were neglected in order to avoid the need of a three-dimensional model. The numerical results are given in Figure 16, in terms of thrust-lines and collapse mechanisms, both for the model with and without infill. The ultimate load factor increases 45% if the infill is removed, which seems also natural because it was not originally planned for this construction.

Figure 16. Results of the numerical analysis, in terms of thrust-lines and failure mechanisms: (a) with infill, for a ultimate load factor equal to 6.5; (b) without infill, for a ultimate load factor equal to 9.4.

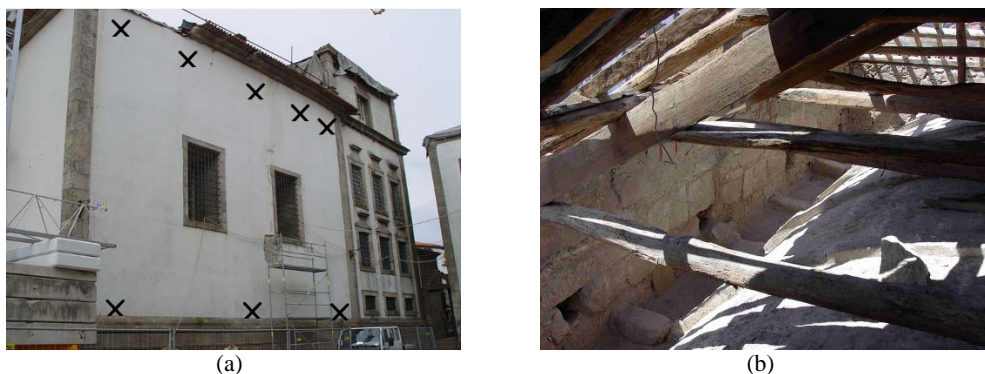
Figure 17. Infill removal: (a) location of topographic targets for monitoring; (b) aspect of the cleaned vault.

The infill was removed but, for safety reasons, it was recommended to accompany this task with topographic measurements, see Figure 17a. The targets were read always at early morning to reduce temperature effects, daily during the process of infill removal (one week) and weekly during one month after load removal. Approximately 35 m<sup>3</sup> (7000 kg) of rubble were removed from the vault and no movements were recorded in the targets. Figure 17b demonstrates that (a) the vault was never conceived to accommodate infill and (b) a timber roof existed at the level of the vault, before the construction of the vault and the new roof at a higher level.
